#13013

May 20, 2013

REPORT OF MARINE SURVEY OF THE VESSEL

DOWAGER

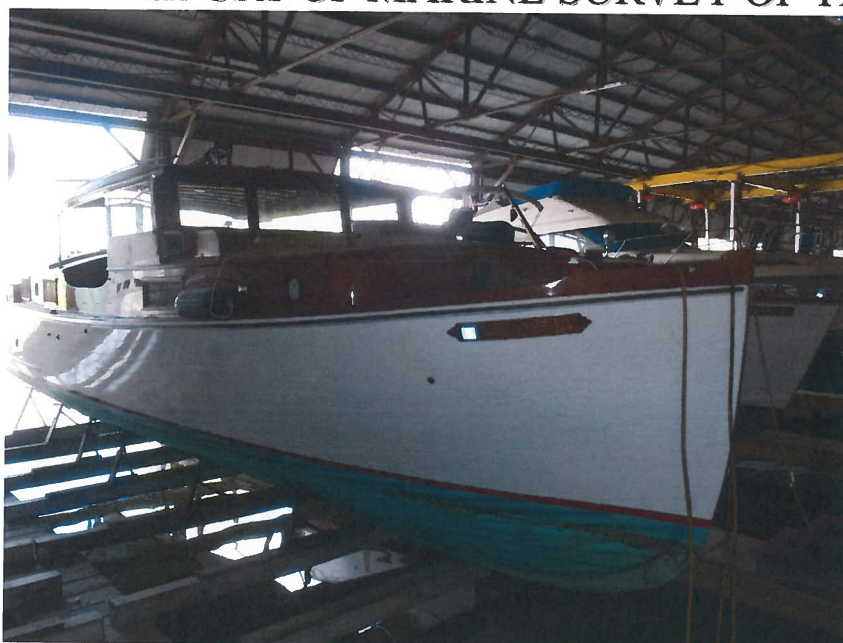
Current photo

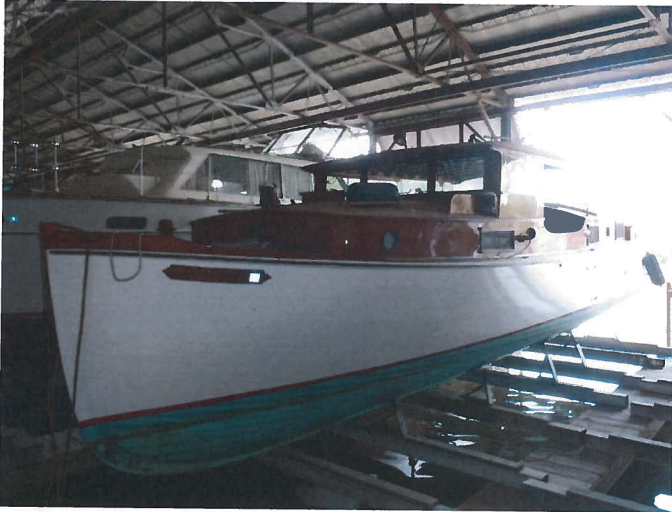
A. HULL, DECK, AND SUPERSTRUCTURE

The 1998-2002 rebuilding included replacing all 132 white oak ribs, new epoxy laminated white oak keel, shaft log, horn timber and stem, new mahogany bottom planking on both sides, scarfed topside planking to eliminate all butt joints above the waterline, a new mahogany transom, new cedar tongue and groove deck planking and new painted canvas deck covering. Everything else was refinished. Silicon bronze fasteners were used throughout.

Condition: Excellent. The Hull is extremely fair and true to her lines with no hogging, deformation, loose or "proud" planking. No fasteners or bungs are popped or bleeding. The topside planking is painted a glossy white and shows very little wear and some dirt from storage but no peeling or damage. There are no open seams or even cracked paint over the topside seams attesting to the excellent refit and refastening in 2002 and the favorable conditions in the fresh water boat house where the boat is stored.

No damage or repairs are observed above or below the waterline. The plank seams, stem, keel, horn timber and deadwood appear quite tight with little contraction noticed. The transom is highly varnished with no signs of flaking or peeling varnish. The transom corners are sound and well calked. On the interior there are clearing chains in the limber holes and the bilge is in very good condition. No decay or soft spots were noted.

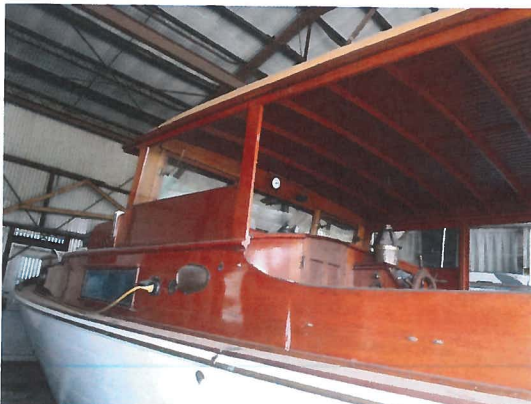
Decks: Cedar tongue and groove decking over white oak beams covered with painted canvas.

Condition: The foredeck cedar planking was replaced and new deck canvas was installed from bow to stern as part of the restoration. The deck canvas is well covered with paint and appears to be sealed adequately but there are a few areas where the canvas has detached from the cedar planking below. These areas are not wet or soft. This condition has not changed or advanced since the last survey in 2009 as the boat is kept in a covered boat house winter and summer. *C1

***C1 Pg 5.** The deck canvas is well covered with paint and appears to be sealed adequately but there are a few areas where the canvas has detached from the cedar planking below. These areas are not wet or soft. This condition has not changed or advanced since the last survey in 2009.

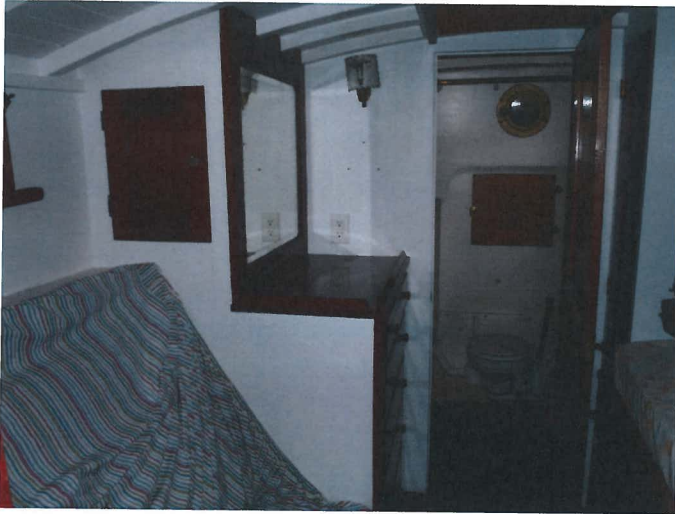
B. CABIN

The interior living spaces of this vessel are in show room condition with no peeling or weather damage. All built in furniture, doors and trim are highly varnished and all other surfaces are painted white. The cockpit and cabin soles inside and out are covered with a patterned one piece vinyl with brass trim.

Condition: Excellent condition. Even the most recessed corners are holding paint and varnish.

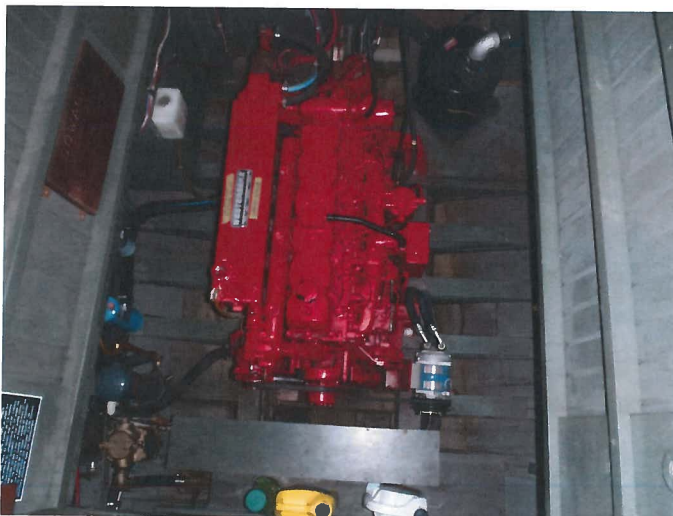
C. PROPULSION SYSTEM

Engine: 1988 Westerbeke m#W100 (6) cylinder diesel spec# HBW 360A s# U1590C805 with closed cooling system. **Condition:** Clean and securely mounted with shock absorbing rubber and steel motor mounts bolted to sound stringers. The crank case is full of very clean lubricating oil. All hoses and belts appear to be in very good condition. The engine space is clean, oil free and well organized.

Note: There is a corroded ferrous bolt in the shaft log/ stuffing box. Replace with a non ferrous bolt. *B1

***B1 Pg 7.** There is a corroded ferrous bolt in the shaft log/ stuffing box.

Recommendation: Replace with a non ferrous bolt.

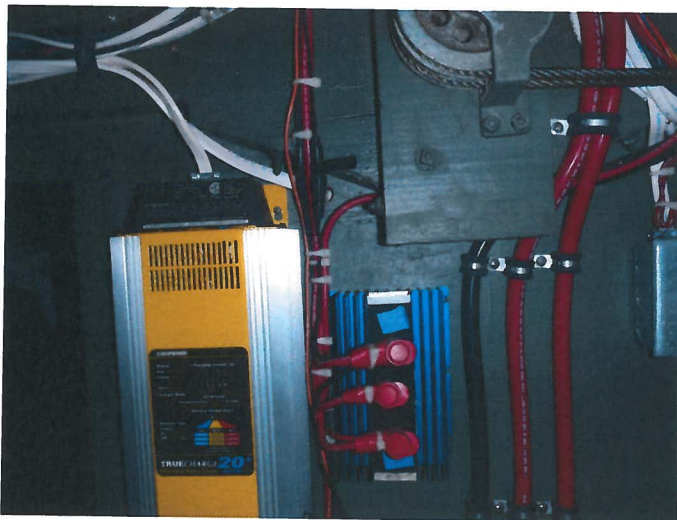
D. ELECTRICAL SYSTEMS

All wiring sighted is of Anchor marine grade stranded wire, supported and connected to ABYC standards. The AC outlets are protected with GFCIs throughout and all were tested for proper function and polarity as part of this survey.

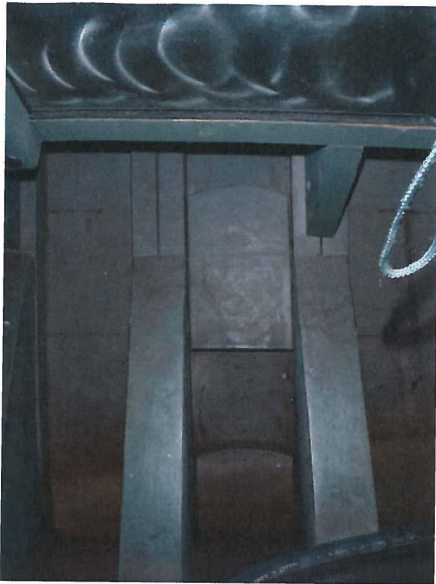
The engine beds, floors and ribs are all in excellent condition. The butt blocks are beveled and radiused to promote drainage and have adequate space on either side.

Properly installed beveled and radiused butt blocks

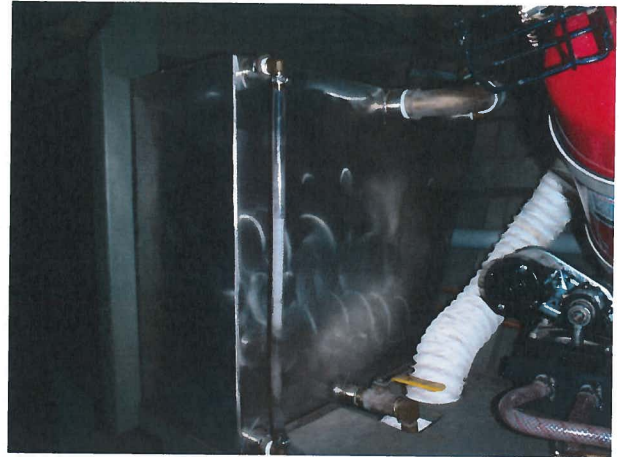
Water Tank

Condition: Well mounted and in like new condition.

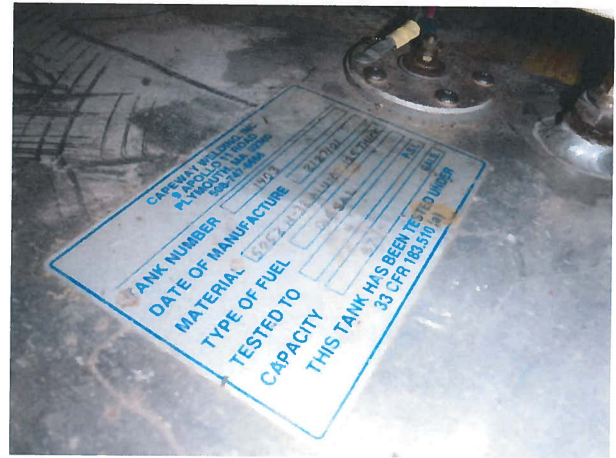
Fuel Tank

Fuel Tanks: (2) Clearly labeled 67 gal, 5052 H-32, .125 thick aluminum fuel tanks by Capeway welding of Plymouth MA, (508-747-6666), properly grounded and tested to 4psi and USCG 33 CFR 183.510(a). Installation of fuel system is in compliance with ABYC H-33.10 standard for Diesel Fuel Systems and NFPA 302 5-2 thru 5-6. **Condition:** Good condition with no evident leaks.

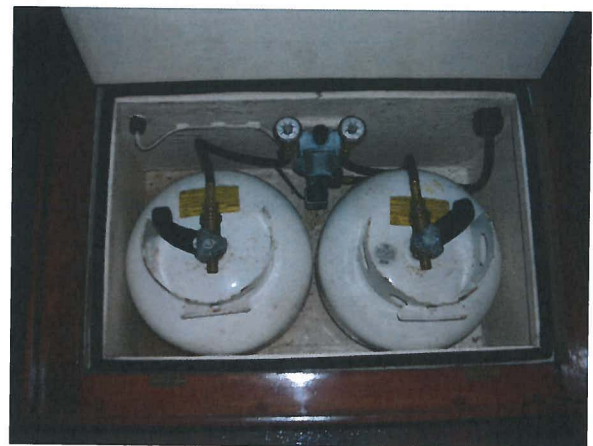
Condition: The installation, fuel lines wiring and LPG locker comply with ABYC A-1 recommended standard for Marine Liquefied Petroleum Gas Systems and NFPA 302 6-5.11.

ABYC compliant propane locker
